Montserrat Volcano Observatory

5 November 2017
9:00 am

Significant Changes to Sinkhole at NW Bluff

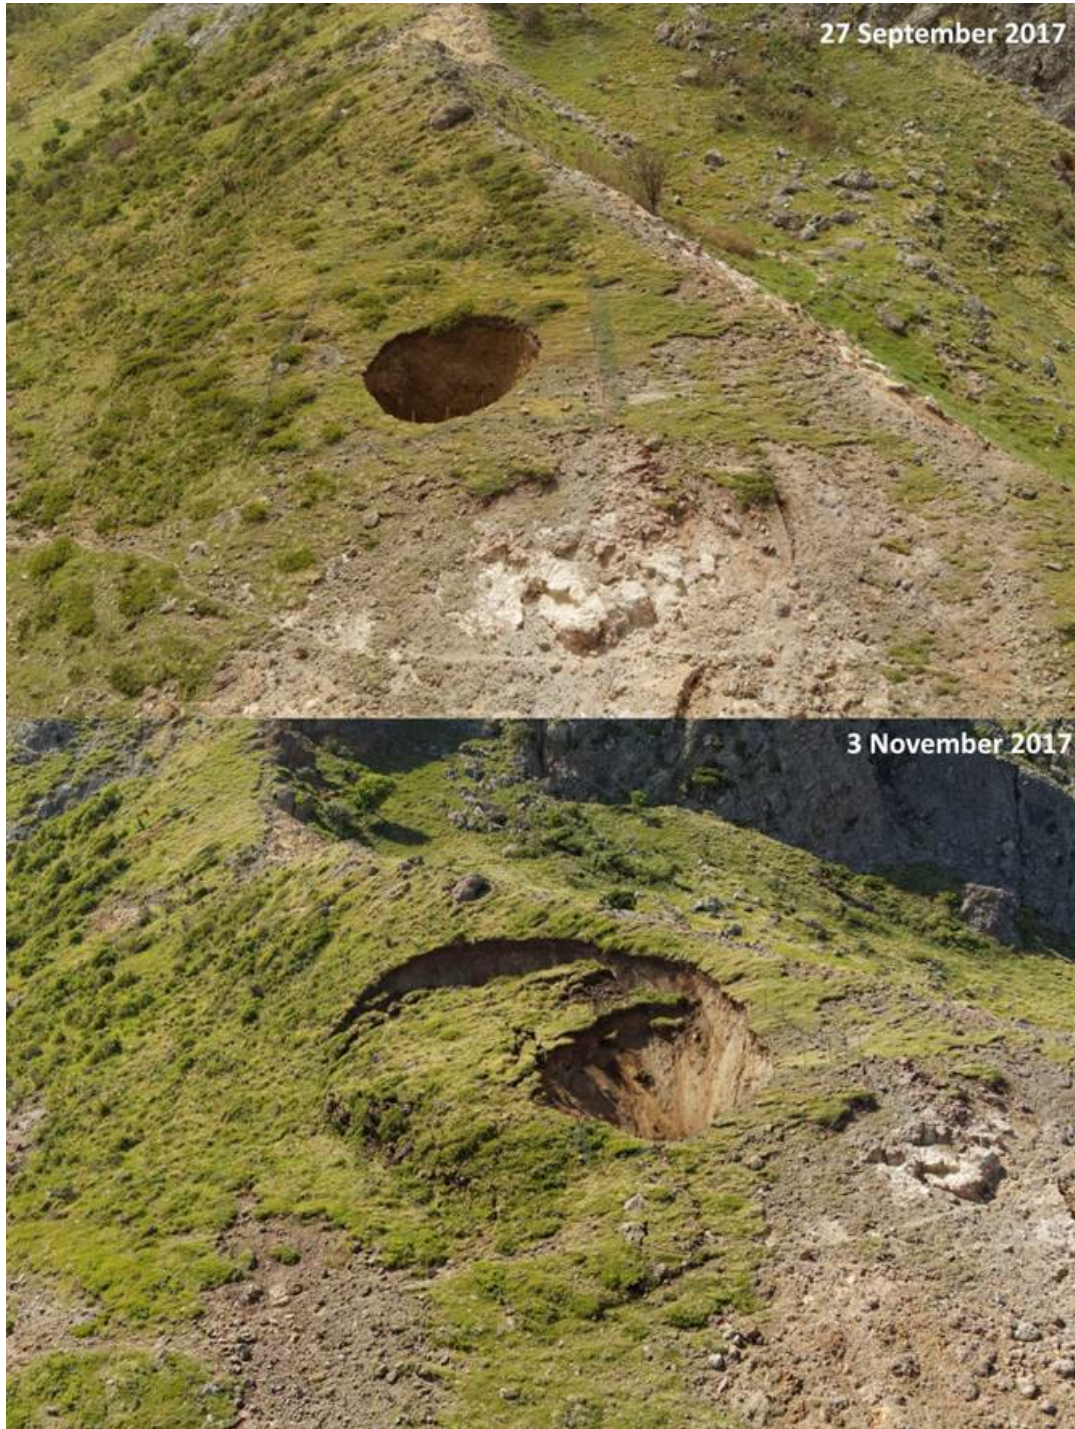
During a helicopter observation flight on 3 November 2017, staff from MVO observed changes to the sinkhole since the previous observations on 27 September, nine days after the passage of Hurricane Maria. The width of the sinkhole at the surface had increased from approximately 10 metres to more than 20 metres and there is evidence that large quantities of material collapsed into the sinkhole. In addition, a small landslide measuring approximately 35 metres across and 50 metres long has occurred along the southern and eastern sides of the sinkhole. This landslide appears to be moving towards the northeast. The photographs show the sinkhole on 27 September and 3 November 2017.

Approximately half of the protective fence installed to prevent people and animals from falling into the sinkhole has itself fallen into the sinkhole. During the observation flight, MVO staff saw small collapses from the walls of the sinkhole indicating that the ground is still unstable and that further collapses and movement of the landslide are likely to take place.

Photographs comparing the NW Bluff sinkhole on 27 September and 3 November 2017. The two photos are taken from slightly different directions but can be orientated using the ridge above the sinkhole and the outcrop of white rocks next to it. Photos : Adam Stinton, MVO.

The cause of these recent changes is probably related to the very heavy rainfall during the passage of Hurricane Maria when MVO recorded approximately seven inches (18 cm) of rainfall. Further heavy rainfall could increase the likelihood of more changes to the sinkhole.

The public is strongly urged to stay away from the area. MVO will continue to monitor the situation and will provide updates when necessary.
